BANK CAVING INVESTIGATIONS
MORVILLE REVETMENT, MISSISSIPPI RIVER

TECHNICAL MEMORANDUM NO. 3-318

BY
WATERWAYS EXPERIMENT STATION
VICKSBURG, MISSISSIPPI

SEPTEMBER 1950

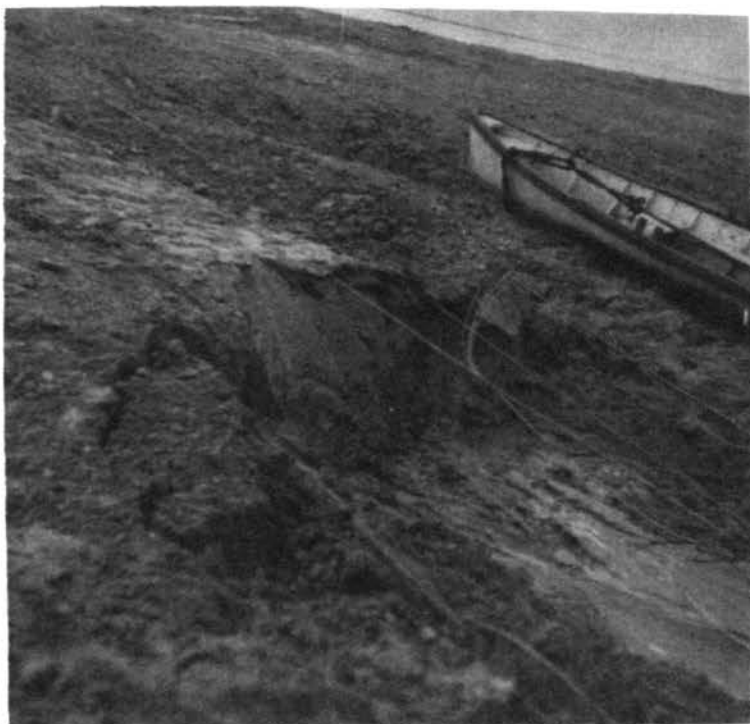
BANK SLUMPING AT RANGE 10-D

14 JUNE 1949
